Community Environmental Response Facilitation Act (CERFA) Report

Pontiac Storage Facility Pontiac, Michigan

April 1994

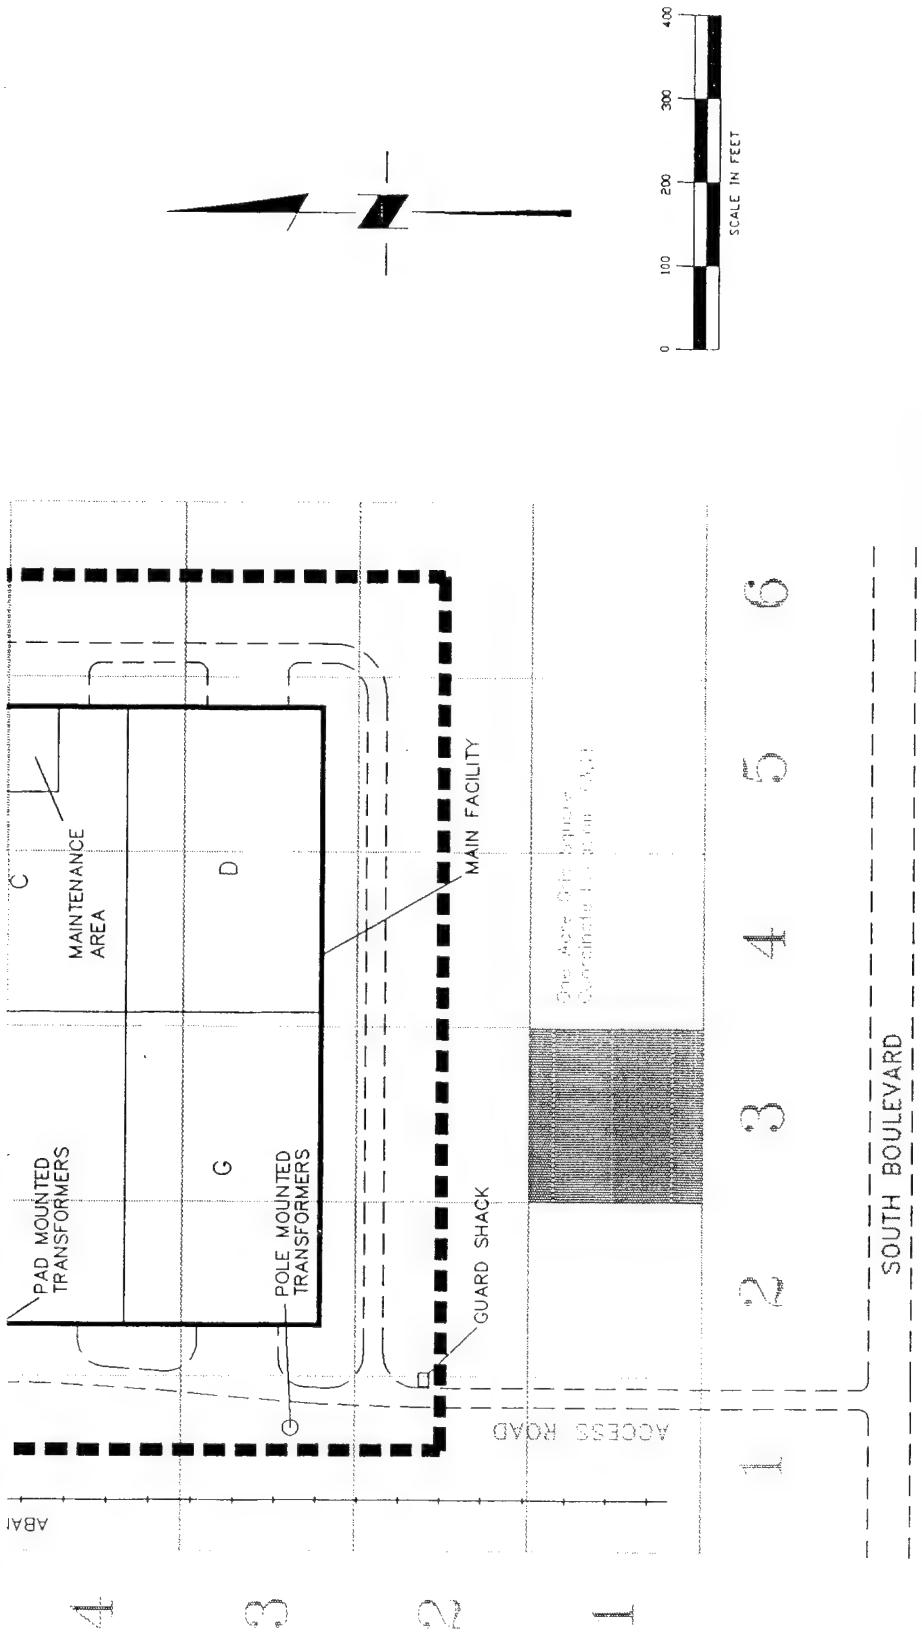
FIGURE 5-1
PARCEL DESIGNATION MAP, PONTIAC
STORAGE FACILITY, PONTIAC, MICHIGAN

AREE No.	Name	Coordinate Location (x,y) Figure 5-1	Parcel Number	Source of Information		Risk (Noncarcinogenic – Hazard Index \geq 1 or Carcinogenic – Risk \geq 1E-04)
				Enhanced Preliminary Assessment (1990)	Environmental Investigation/Risk Assessment (1993)	
1	1,000 gallon heating oil UST	(5,5)	4D	✓	✓	No
2	10,000 gallon heating oil UST	(2,7)	2D	✓	✓	No RA performed
3	1,000 gallon heating oil AGT	(2,6)	2D	✓	✓	No RA performed
4	300 gallon gasoline AGT	(6,7)	3D	✓	✓	No
5	Asbestos	None	None	✓	✓	No (removed)
6	Storage of drummed material	(3,7)	2D	✓	✓	No
7	Paint/solvent storage and use	(5,5)	4D	✓	✓	No RA performed
8	Equipment storage	Multiple	Multiple	✓	✓	No RA performed
9	Electrical equipment (PCB transformers)	(2,5) (1,3)	1P	✓	✓	No
10	Septic sewer system	(2,6)	2D	✓	✓	No RA performed
11	Radon gas	None	None	✓	✓	No RA performed
13	Drainage ditches	(3,7)	2D	✓	✓	No
14	Dehumidifiers blowdown	None	None	✓	✓	No
